**Historic Preservation Commission**  
**Agenda**  
**September 21, 2020**  
**6:30 pm**

**REQUEST:** The applicant requests to Landmark the structure at 633 La Farge Avenue and requests an Alteration Certificate allowing the relocation of the structure currently located at 1201 Lincoln Avenue to the southern portion of the lot.

# HISTORIC STRUCTURAL ASSESSMENT

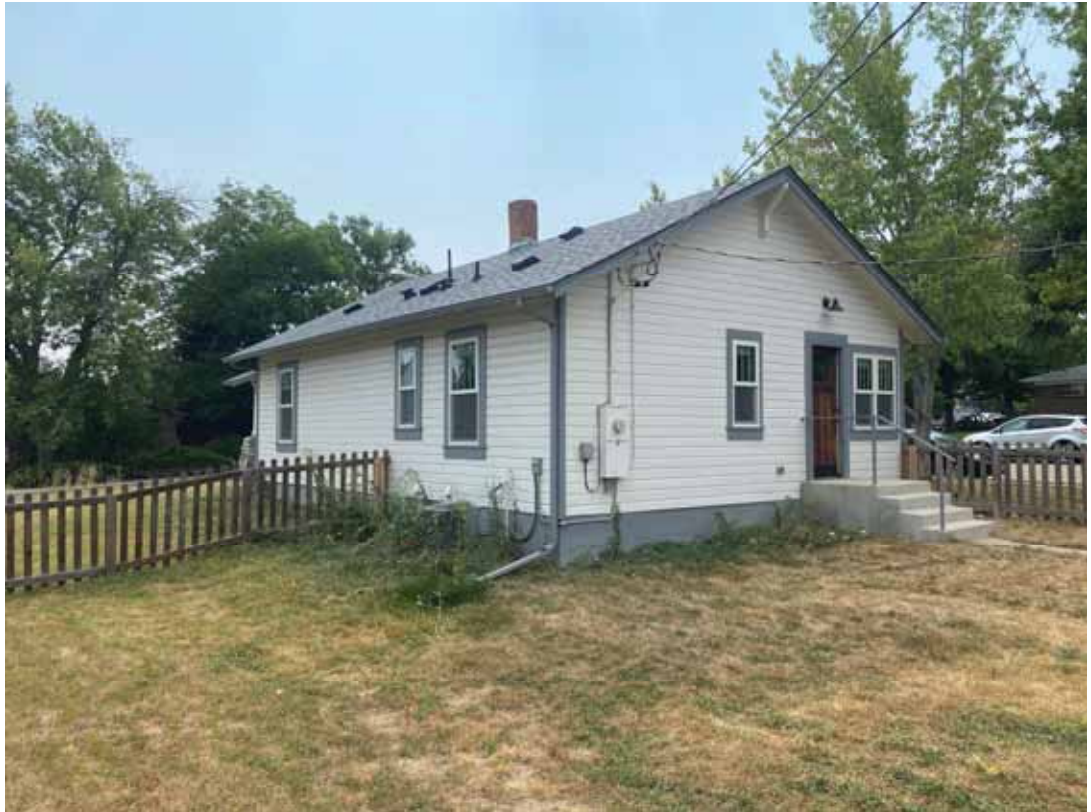
*Northwest corner of the house - The site grades away from the house and generally from the south to the north*

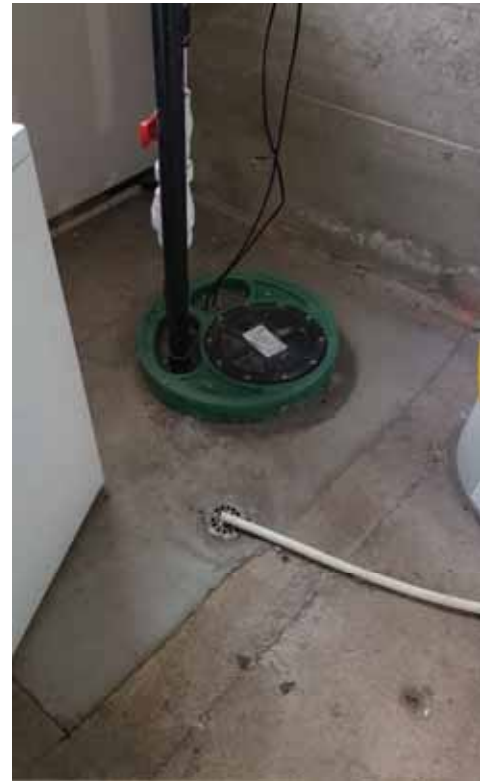
*New and old basement slab*

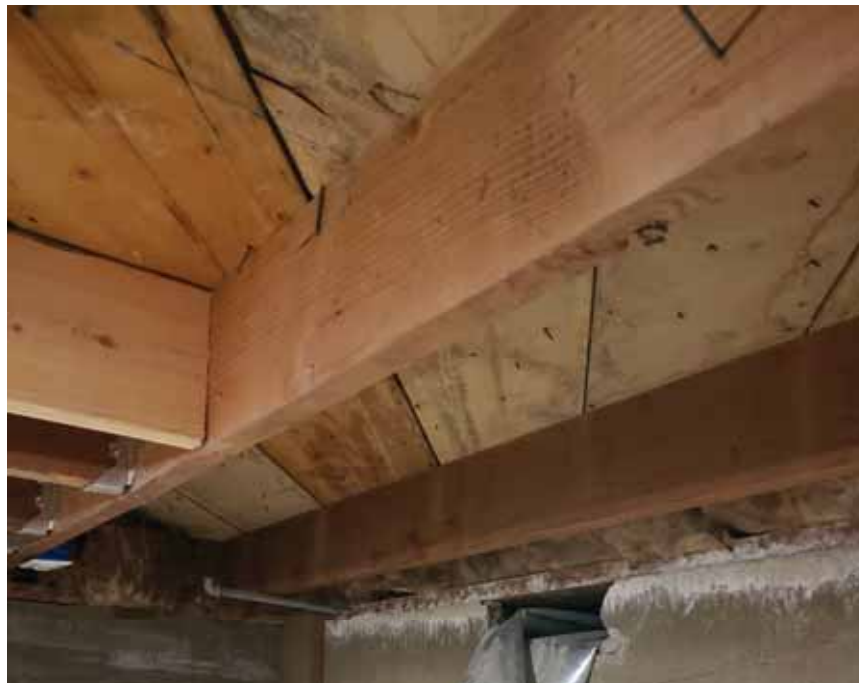
*Original floor framing, new blocking, original floor sheathing, & original sill plate*

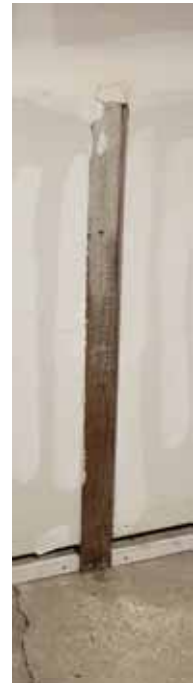
*Original 4x4 post*

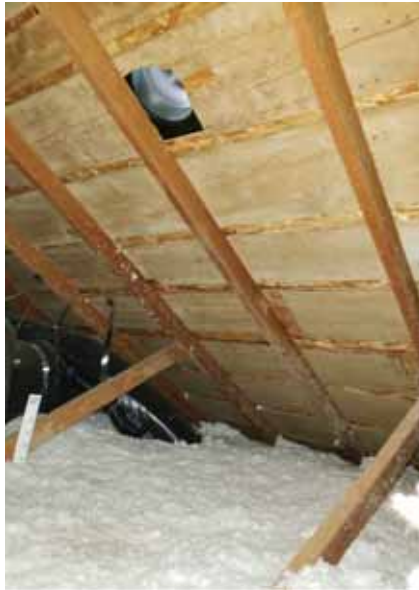
*Roof vent & insulation*

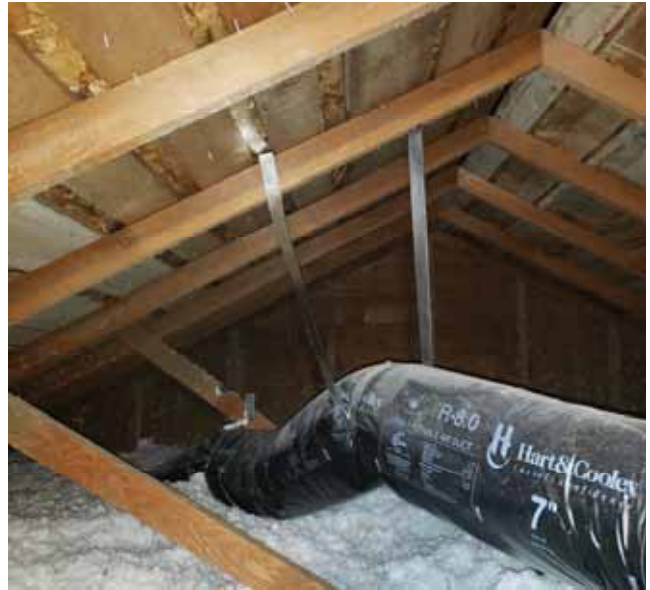
*Roof framing & framing supports, original & new roof sheathing*

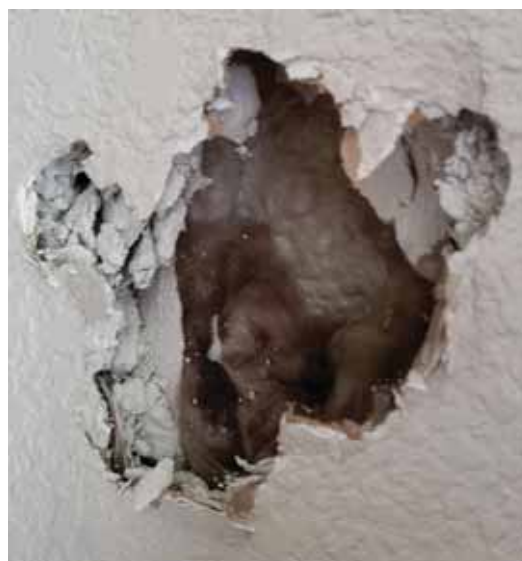
*Exterior wall insulation*

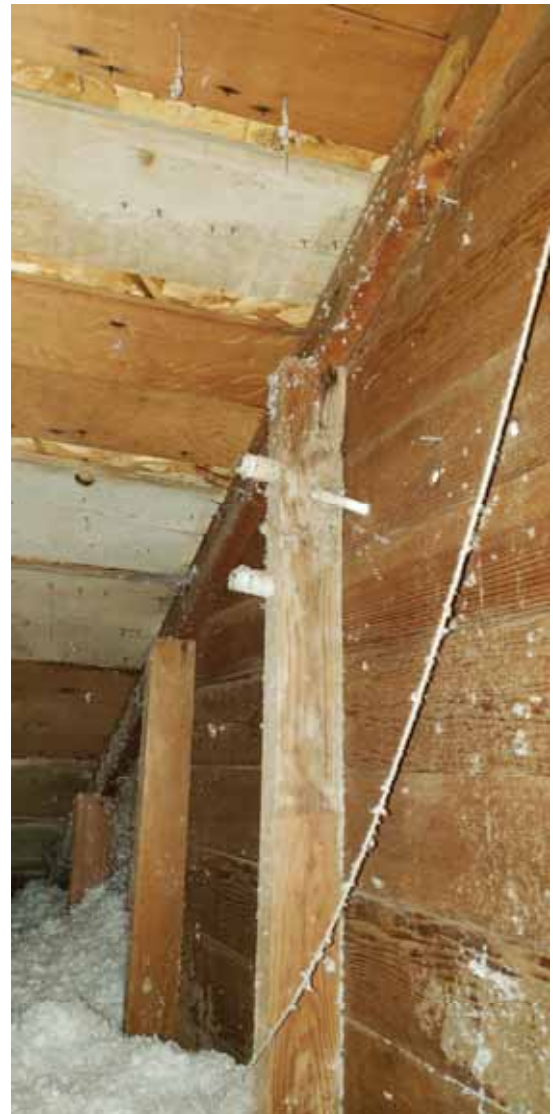
*Gable end wall framing with shiplap siding attached*

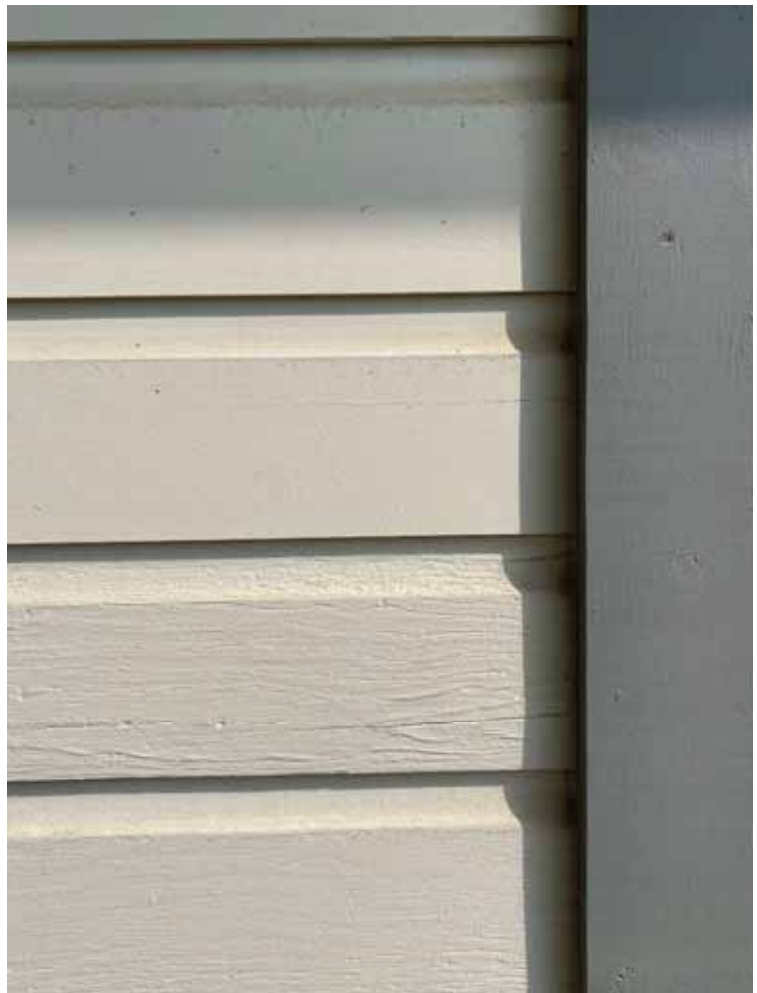
*New (smooth) and original (textured) shiplap siding*

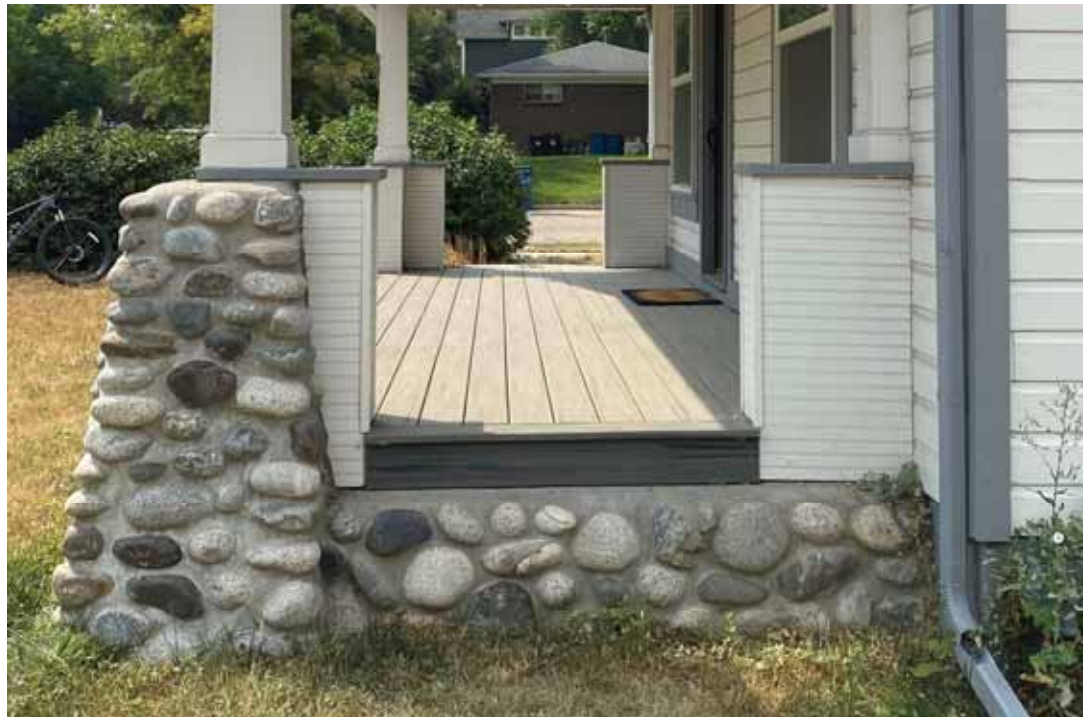
*River rock porch and column base*

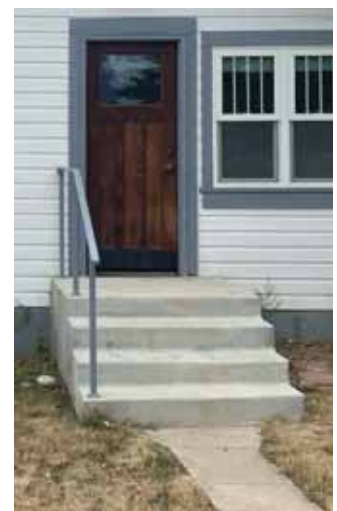
*Rear concrete stoop*

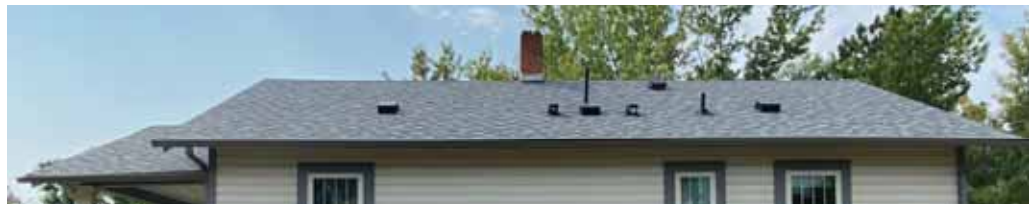
*Asphalt composite shingle roof & roof vents*

No recommendations at this time.

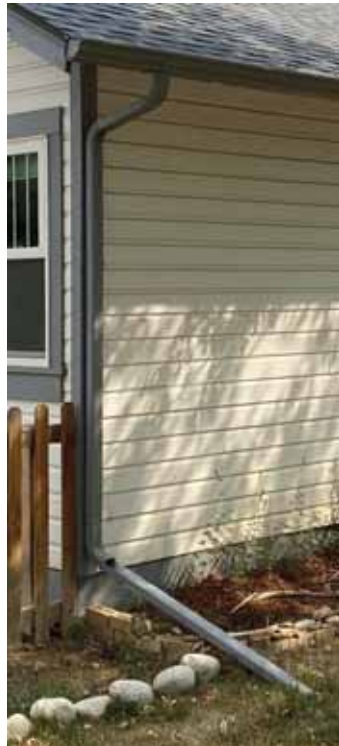
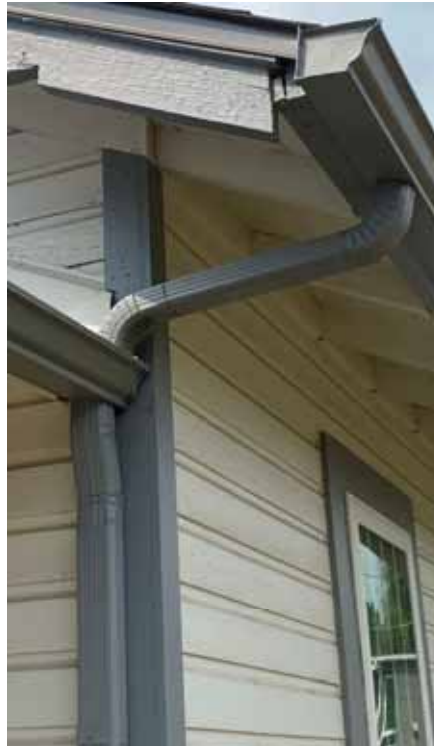
The gutters and downspouts are in good condition.

*Gutter extension*

*Gutters & downspouts*

No recommendations at this time.

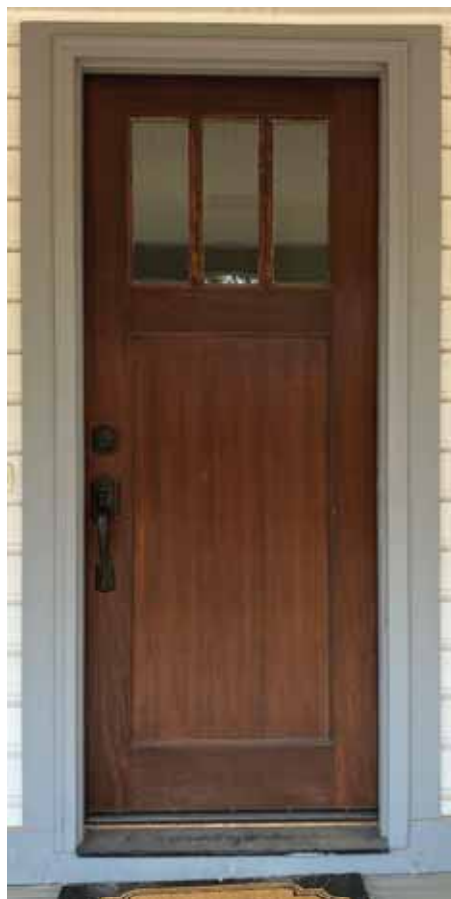
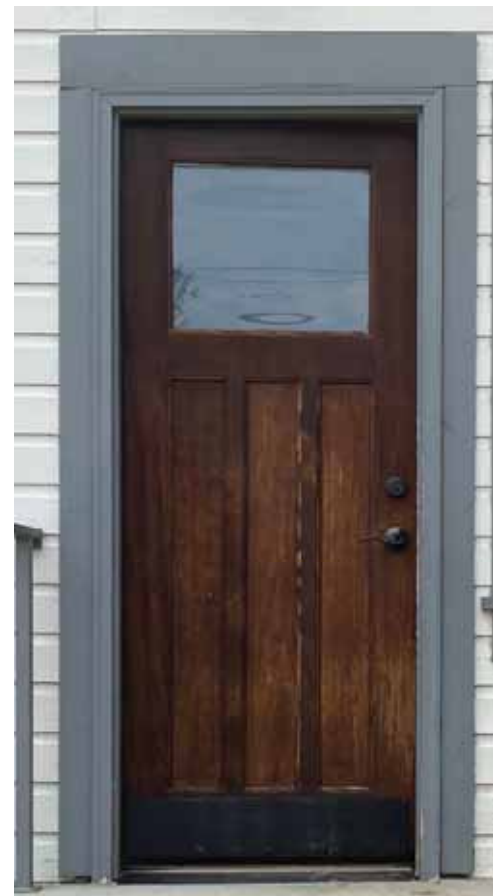
*Front door*

*Back door*

Both the front and rear doors are in fair condition. There are no issues with opening or closing or sealing but both doors have not been re-stained in several years and the wood in several areas is chipping.

1. Refinish and stain the wood front and back doors. Replace the glass in both doors.
2. Alternatively, replace both doors with new doors that match the existing door style.

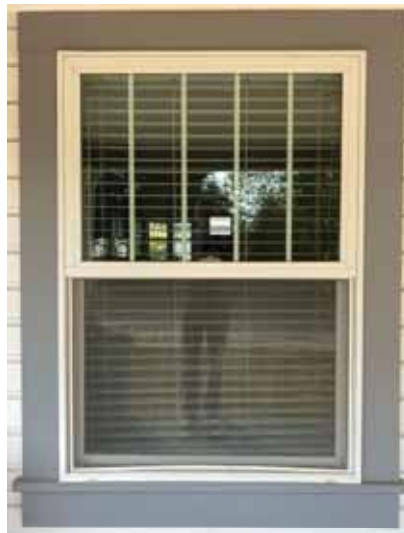
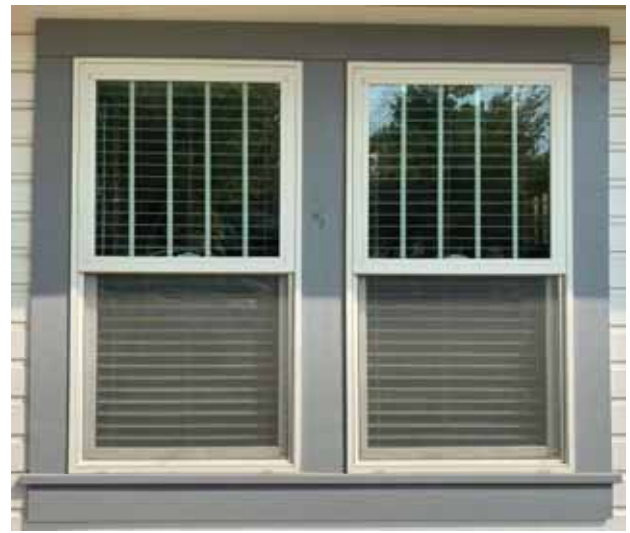
*Typical window*

*1 Typical paired windows*

The existing windows are in good condition as they are all operable, sealed, and show no visible signs of condensation. All the windows were added in 2016 and meet energy code requirements of that time.

Determine original window locations and sizes of the windows that were removed in 2016. This can be done by removing finish materials on the interior or exterior of the house where the original window rough opening is likely still present. Add windows that match the style of windows found on the remainder of the house in these locations. Window style can be determined by consulting city permit records for the 2016 remodel.

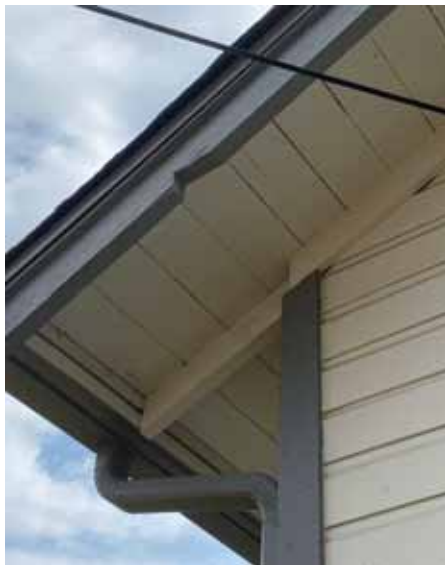
The soffit, fascia, exposed rafters, barge rafters, and exposed roof sheathing are in good condition.

*Rafter tails, roof sheathing, fascia, & barge rafter*

*Bead-board front porch soffit*

No recommendations at this time.

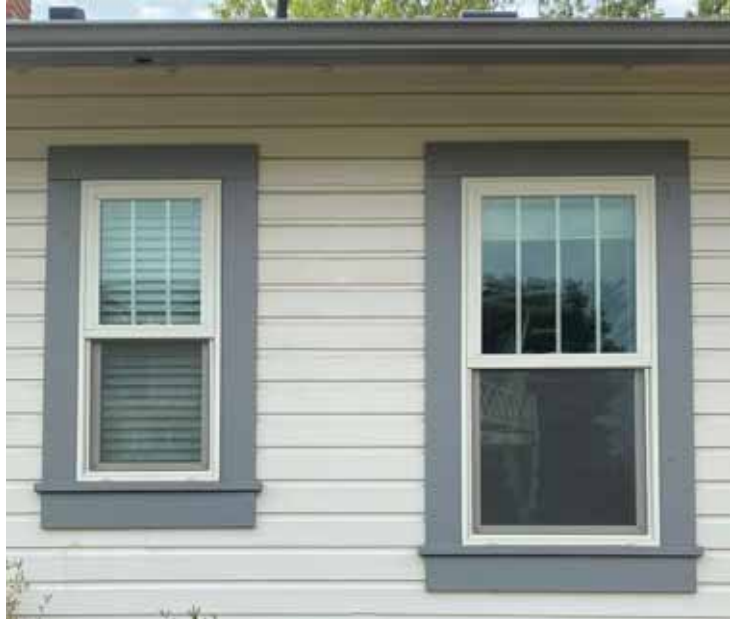
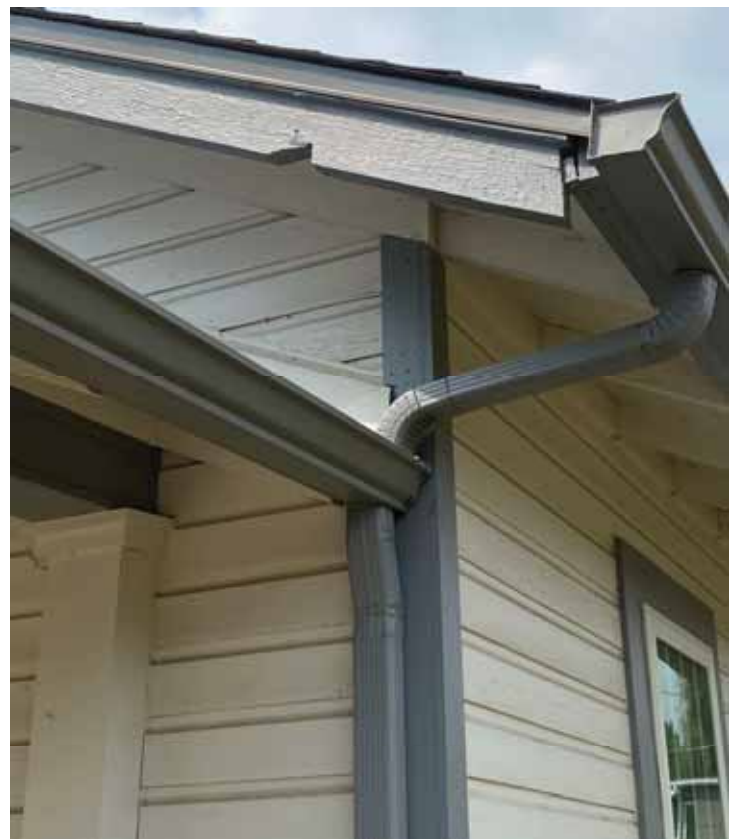
*Typical window trim*

Corner trim, frieze boards, and window trim are all in good condition and were replaced in 2016.

*Corner trim & frieze board*

No recommendations at this time.

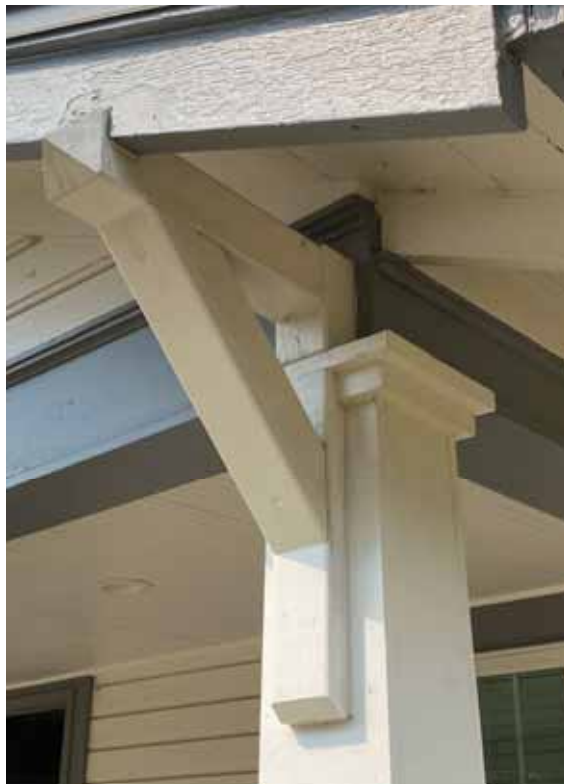
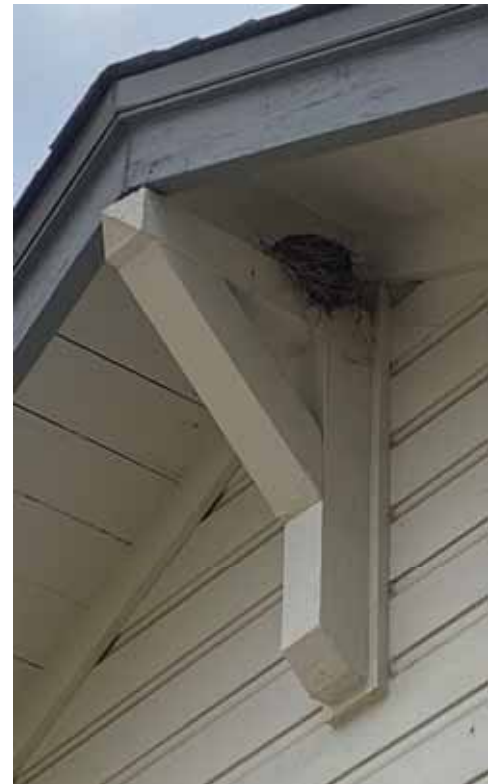
The gable end brackets are in good condition.

*Covered porch bracket*

*Gable ridge bracket*

Replace the missing brackets at the eaves of the main house with brackets that match the existing brackets on the front porch gable. Location of the brackets should be determined based on the 1948 photo and the notches made in the barge rafters.

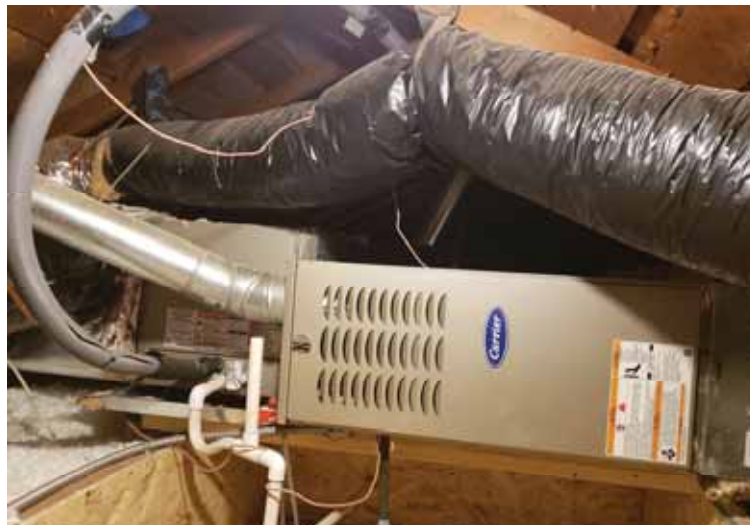
The furnace and air conditioning appear to be in good condition but were not tested during the site visit. The supply lines are in fair condition. Where the flexible ductwork is supported, several areas pinch and compress the duct insulation, reducing the overall insulating effectiveness.

*Furnace & ductwork in the attic*

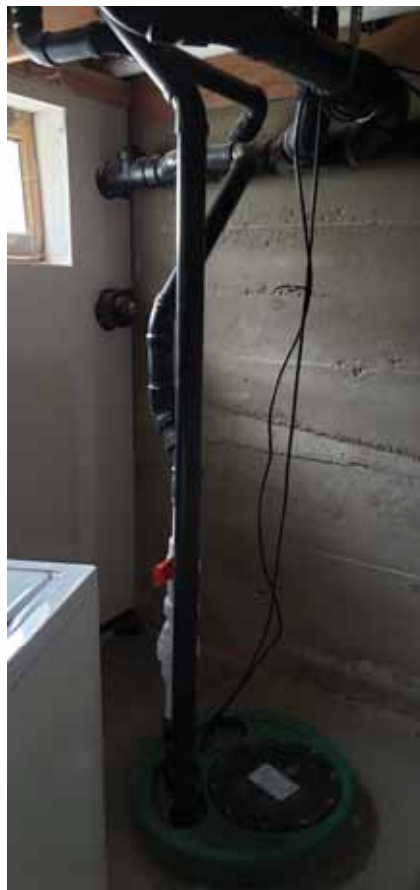
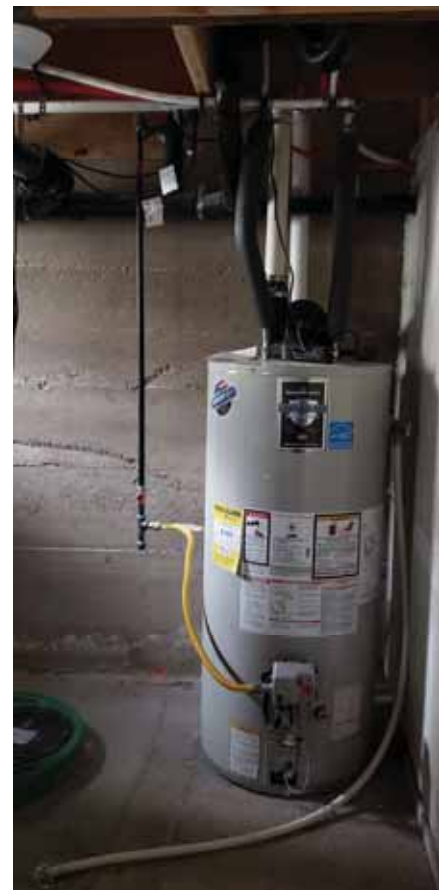
The water heater, water distribution system, ejector pit, and sewer lines are in good condition.

*Ejector pit & sewer*

*Water heater & plumbing lines*

No recommendations at this time.

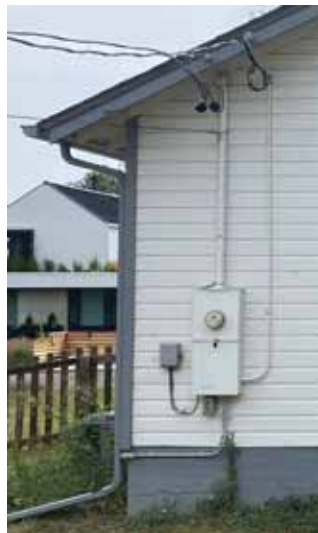
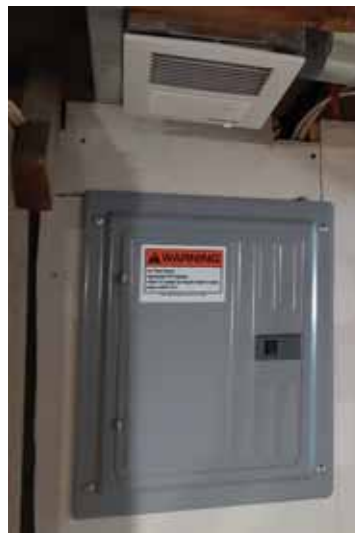
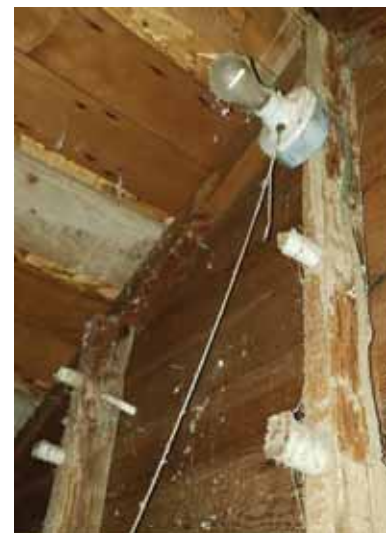
The electrical service and wiring are in good condition.

*Overhead elec., panel, & meter*

*House sub-panel in basement*

*Abandoned knob & tube elec. in attic*

No recommendations at this time.

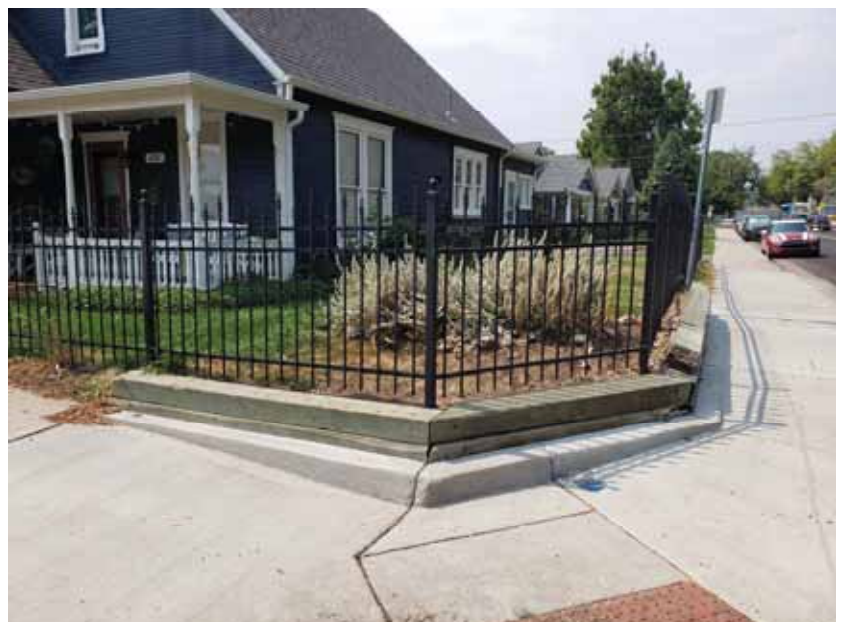
*Built-up grading and retaining wall - northeast property corner*

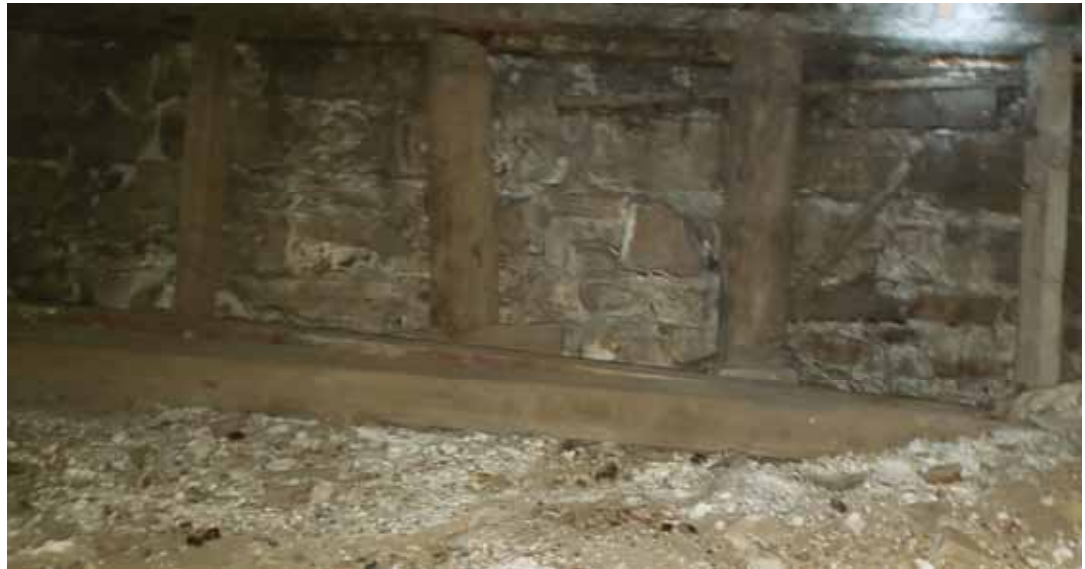
*Original stone foundation*

1. Repair the crawlspace beam line and provide concrete foundation supports below each of the new and existing posts.
2. All exposed stone foundations should be repaired and repointed. The north foundation wall, towards the east end of the building, specifically needs repair.
3. Further investigation of the wood/concrete retaining wall between the crawlspace and the basement is needed. Likely, the studs should be replaced and/or properly anchored top and bottom.
4. The newer concrete walls below the original stone walls in the basement should be monitored and/or further investigated. Over time, the joint between the two types of foundation may result in water infiltration and movement. In addition, it is unclear if there is a proper footing below to help retain earth and prevent overturning.

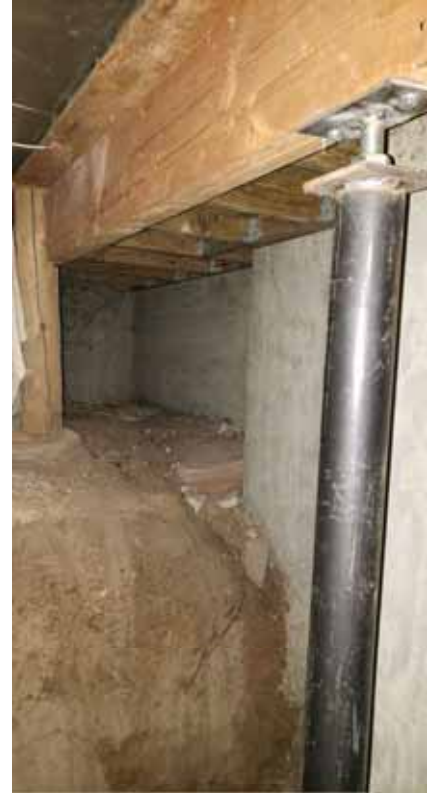
In 2000, the front porch was repaired, and it appears that the concrete foundation under the porch was replaced at this time. New concrete pads to support the new floor framing were built at this time.

*Concrete foundation under front porch*

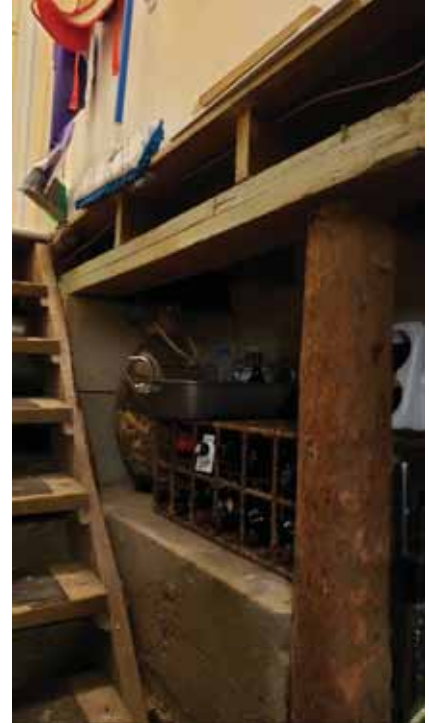
*Basement opening, beam, floor joist, & post*

1. Add additional joists or interior supports to reduce the joist span and help reduce floor deflection.
2. Further review of the double plate being used as a bearing wall to support the main floor, upper floor, and roof framing. Either additional posts or a deeper beam system may be needed to properly support the loads above.
3. Further review, and possible replacement, of the beam and posts in the crawlspace may be required. See *Foundation Systems* section for further information about proper support of the wood posts.
4. Repair and replace the wall structure at the north foundation wall once the foundation issues have been properly addressed as discussed above.
5. Work with a licensed structural engineer to properly provide support of the floor framing around the stair opening to the basement. This will likely require a new structural beam and support of interrupted floor joists.

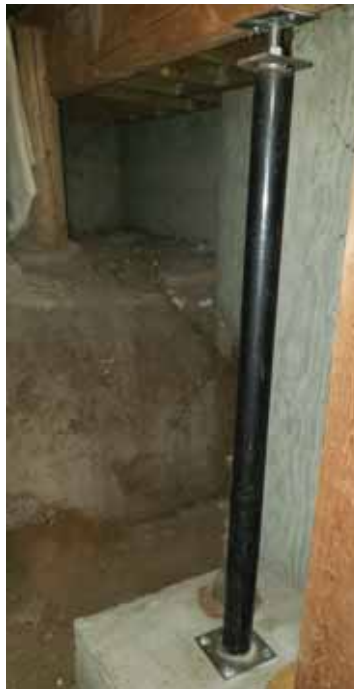
*Adjustable pipe column*

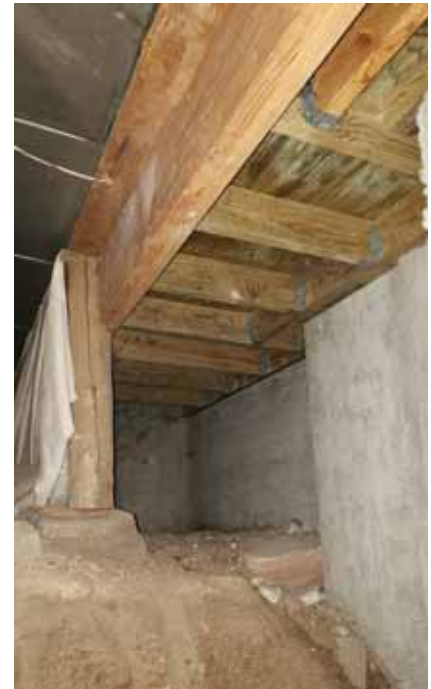
*Framing beneath front porch*

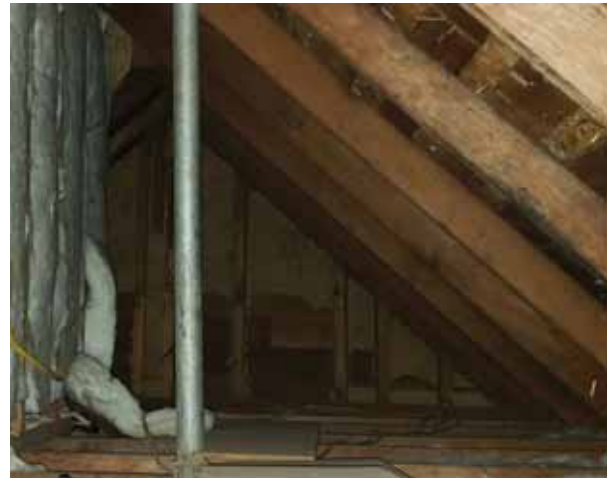
*Gable end wall framing in attic - siding attached directly to studs*

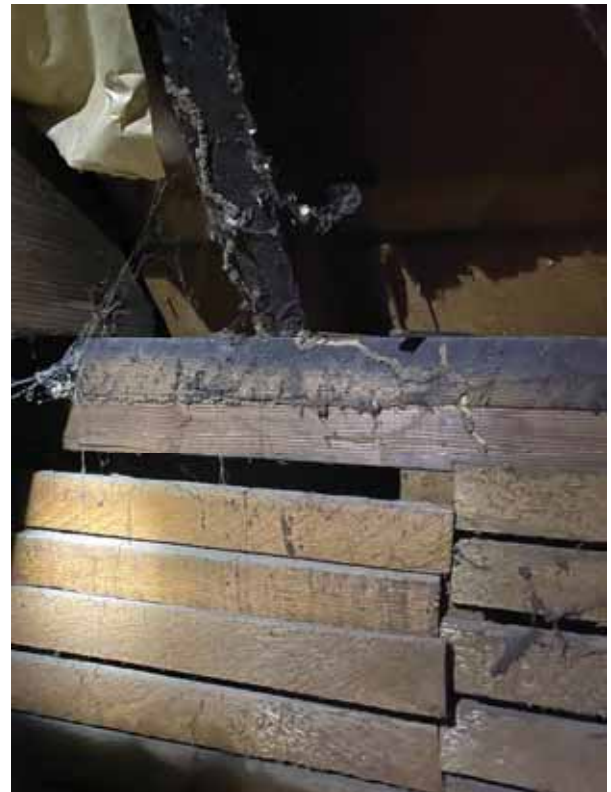
*Wall framing in attic - double top plate, top of stud, & original lathe*

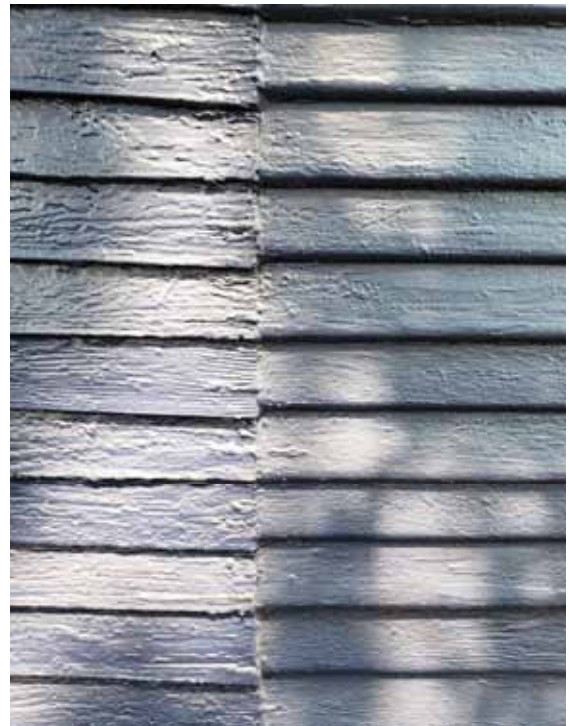
*Original siding (left) and siding found on west addition (right)*

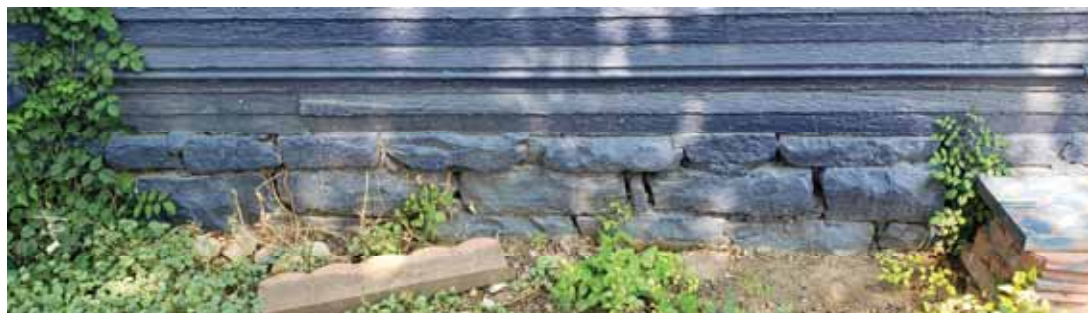
*Original stone foundation*

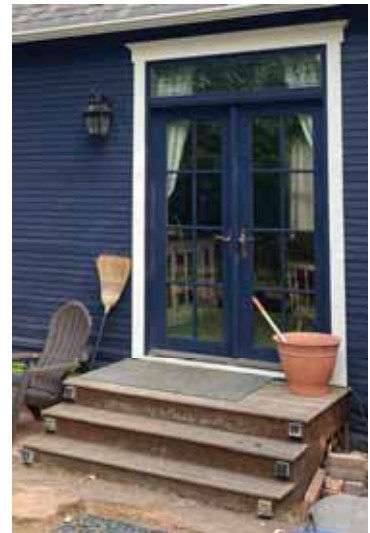
The front porch, west addition, and south landing are in good condition. The foundations and roof structures of the front porch and west addition are addressed in the *Foundation Systems* and *Roof Systems* sections.

*Wood landing on south side of house*

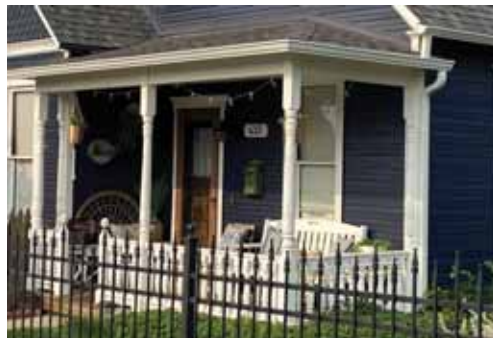
*Covered front porch*

1. Address the foundations and roofs of the front porch and west addition as prescribed in the *Foundation Systems* and *Roof Systems* sections.
2. Consider restoring the front porch to a screened-in porch. The screened in porch appears to be original as it is present as early as the 1913 photo. The 1960's photo can be used to re-create the porch. The tapered half-wall with wood shake-shingle siding is a common feature on houses built around the same time in the Louisville area and several examples still exist.

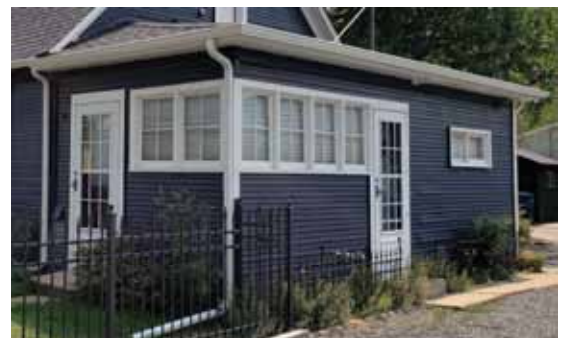
*West addition*

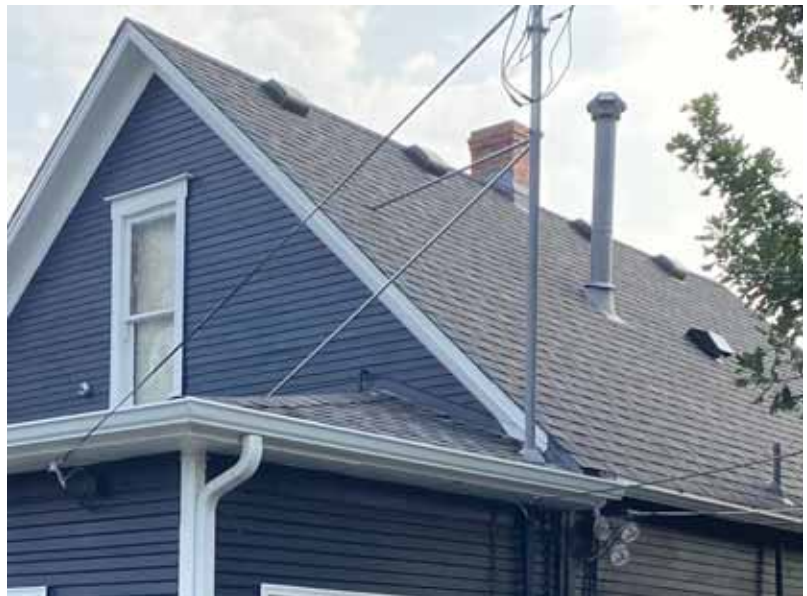
The asphalt composite shingle roof and roof venting are in good condition.

The metal flashing is in good condition.

*Asphalt composite shingles, roof venting, & metal flashing at low roof & chimney*

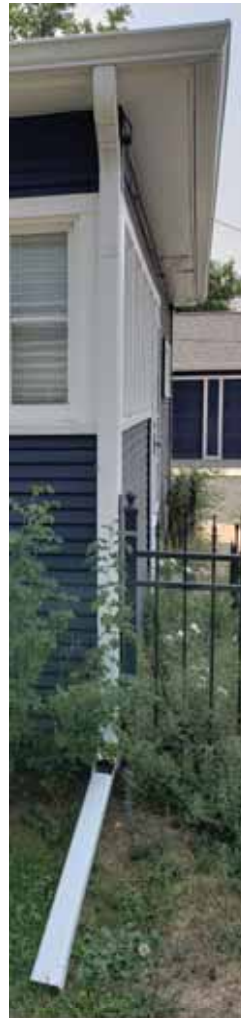
All of the downspouts, except for the one in the southwest corner, have adequate gutter extensions directing water several feet away from the house foundation. The downspout in the southwest corner discharges directly at the house footprint. Gutters and downspouts do not appear in the 1960's photo and were likely added in 1998.

*Proper downspout extension*

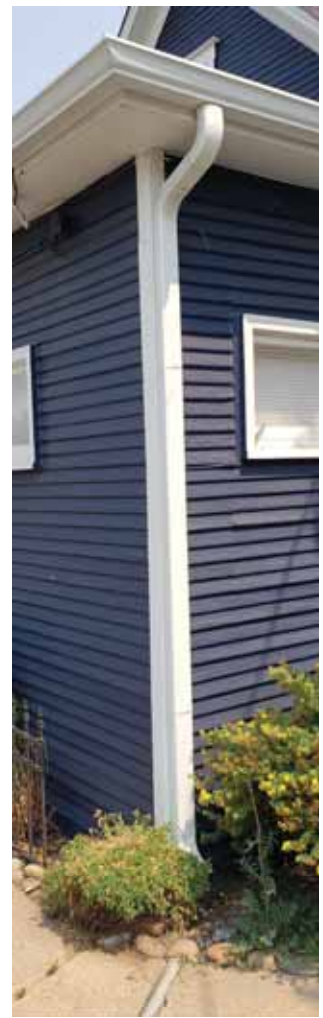
The gutters and downspouts are in good condition. The discharge location of the downspout in the southwest corner is in poor condition as it discharges water next to the foundation, with the potential to cause foundational damage.

*Add flexible downspout extension*

Add an extension to the downspout in the southwest corner. This downspout is near a concrete path so a flexible extension is recommended to divert water away from the house foundation without creating a tripping hazard in the walk path.

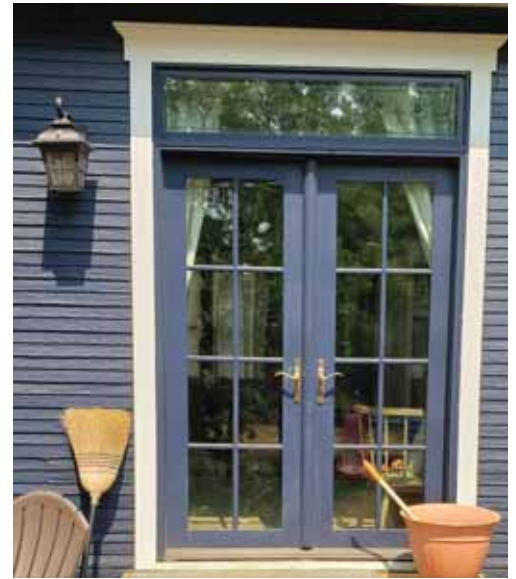
On the south side of the original house is a painted wood French door with full divided lites and a transom. According to city records, this door was added in 2001 and replaced a window in this location.

*South side French door*

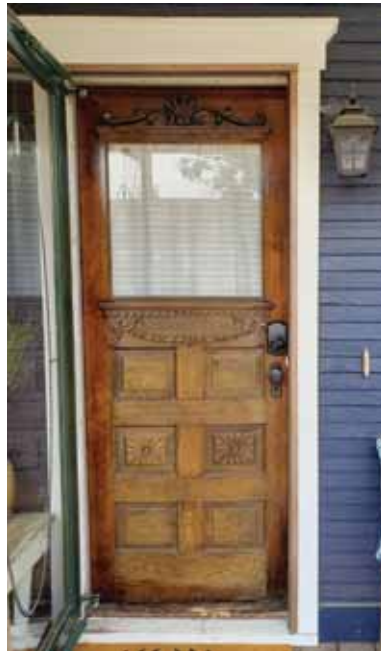
The front door is a stained wood door with a quarter-lite, dentils, and decorative carvings. This door appears to be in the original location and is possibly original as the door style is similar to other historic doors found in the Louisville area. The front door has an aluminum, full-lite storm door.

The north, west, and south doors are in good condition. The front door is in fair condition as it needs to be re-finished. There are no issues with opening, closing, or sealing in any of the doors.

*Front door & storm door*

Re-finish and stain the wood front door.

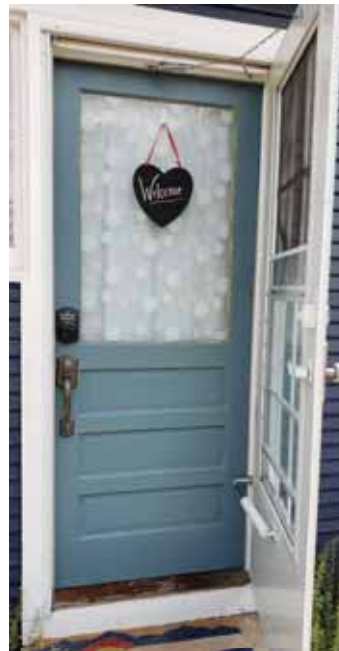
*West door & storm door*

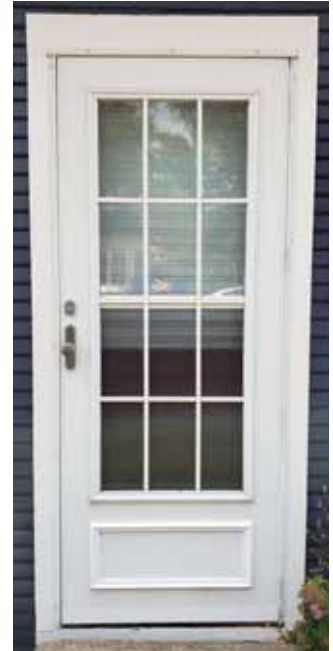
*North door & storm door*

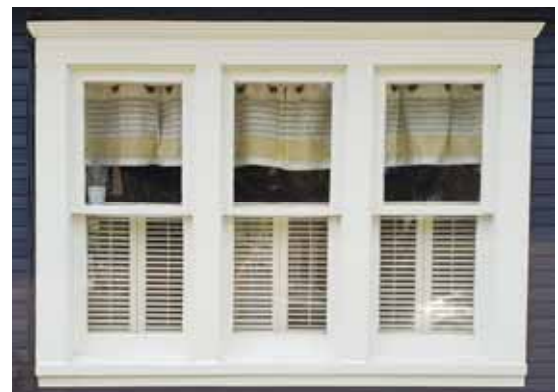
All of the windows are in fair condition. Most of the windows are no longer operable and those that still are show signs of poor sealing.

*Kitchen windows*

1. Replace all windows with new, operable windows that match the styles currently found. The glider windows may or may not be original to these locations. Clues as to the original window sizes may still exist in the framing. If the framing is exposed for repairs in the future, consider replacing these windows with windows matching the style found in the northwest corner of the west addition.
2. Replace the French door on the south side with a tall and narrow window, as found on the remainder of the original house.
3. Replace the window in the bathroom with a taller, single-hung window, as seen in the siding patch, with a window that matches those found on the remainder of the house.

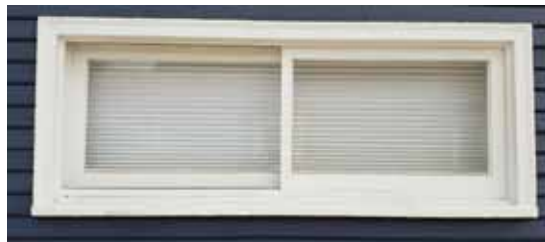
All of the trim is in good condition.

4-piece window trim

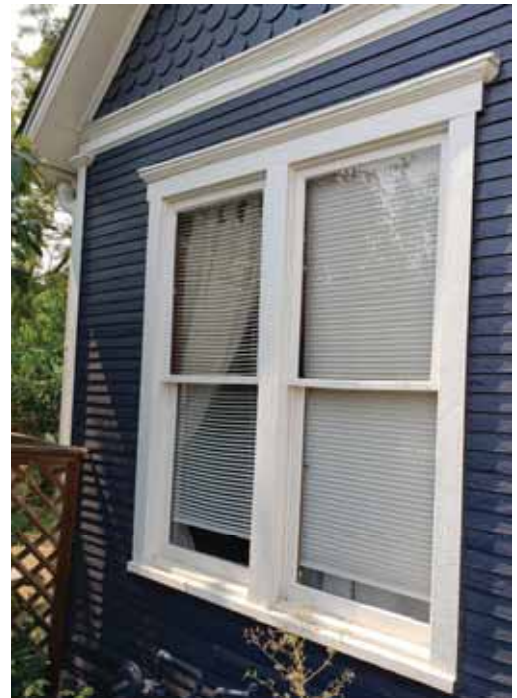
5-piece window trim, corner trim, & cornice

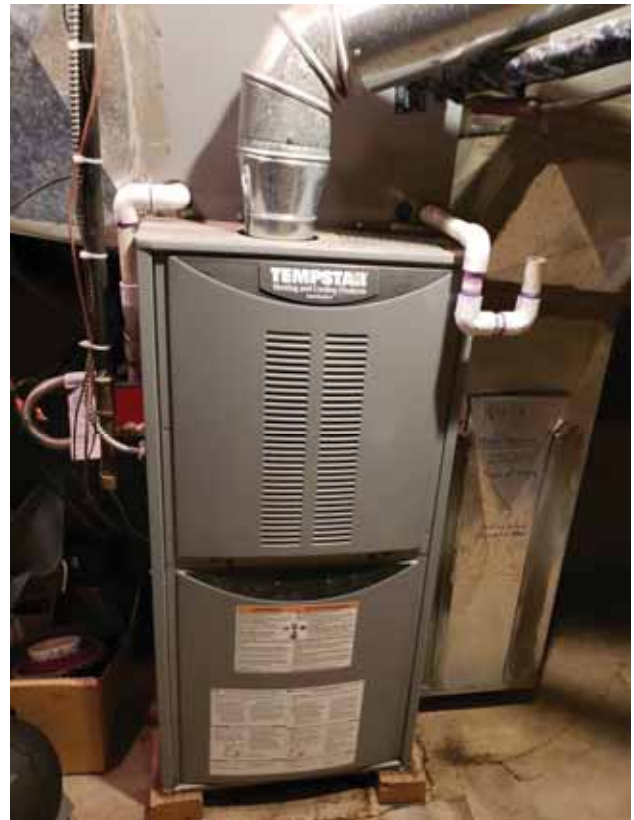
*Forced-air furnace in basement*

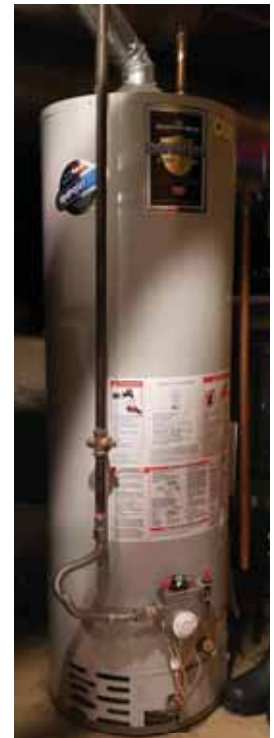
*Water heater*

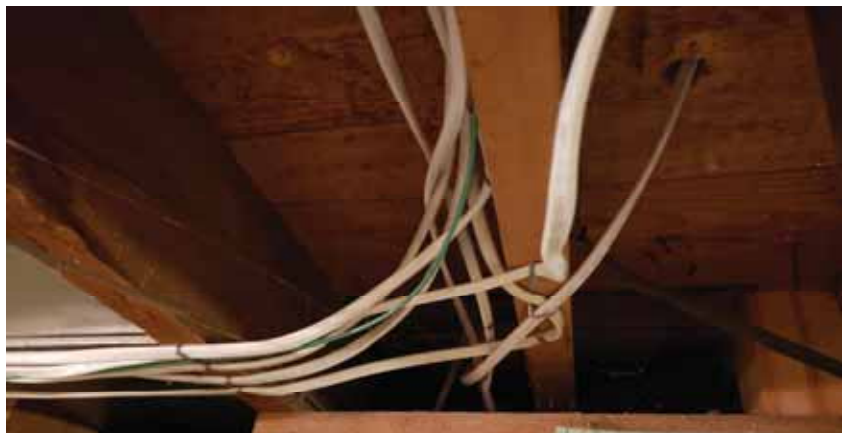
*Romex and original knob & tube wiring in basement*

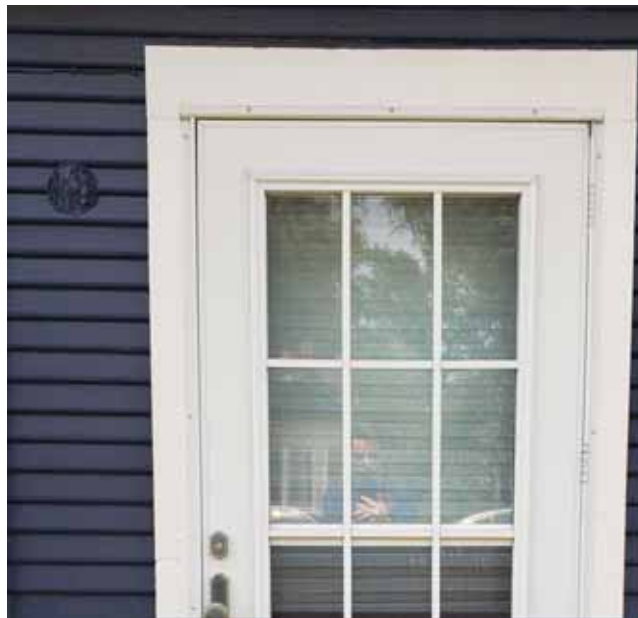
*Patched exterior light location*
